WAYNESBURG WATER COMPANY DAM

NDI I.D. NO: PA-195

PHASE I INSPECTION REPORT  
NATIONAL DAM INSPECTION PROGRAM

D'APPOLONIA CONSULTING ENGINEERS  
10 DUFF ROAD  
PITTSBURGH, PA. 15235  
JANUARY 1979

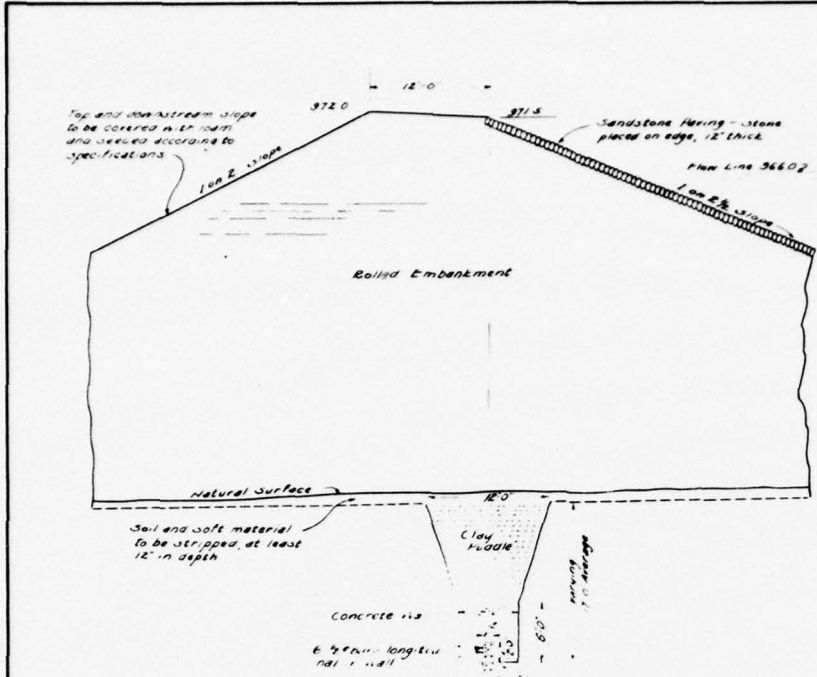
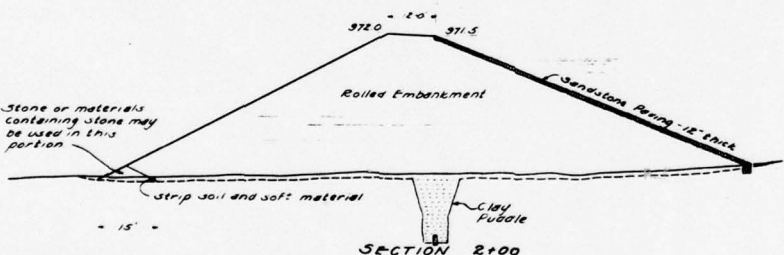
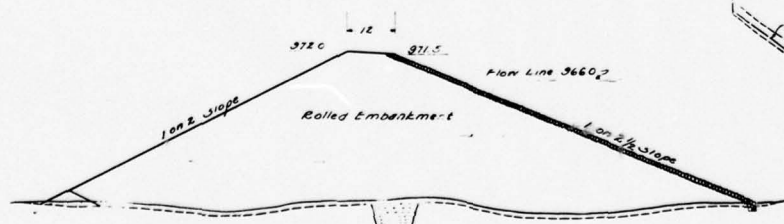
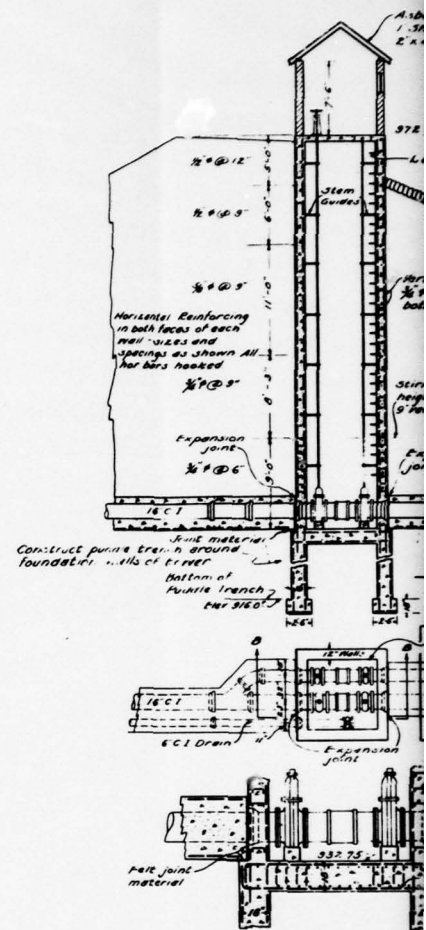
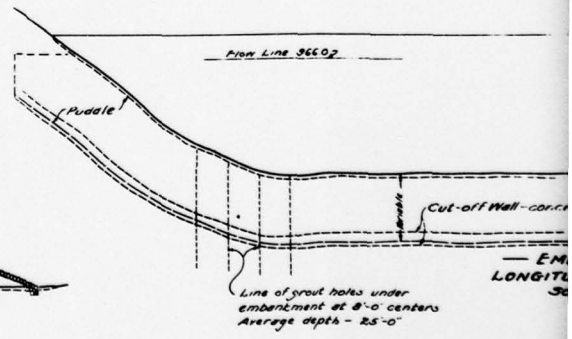
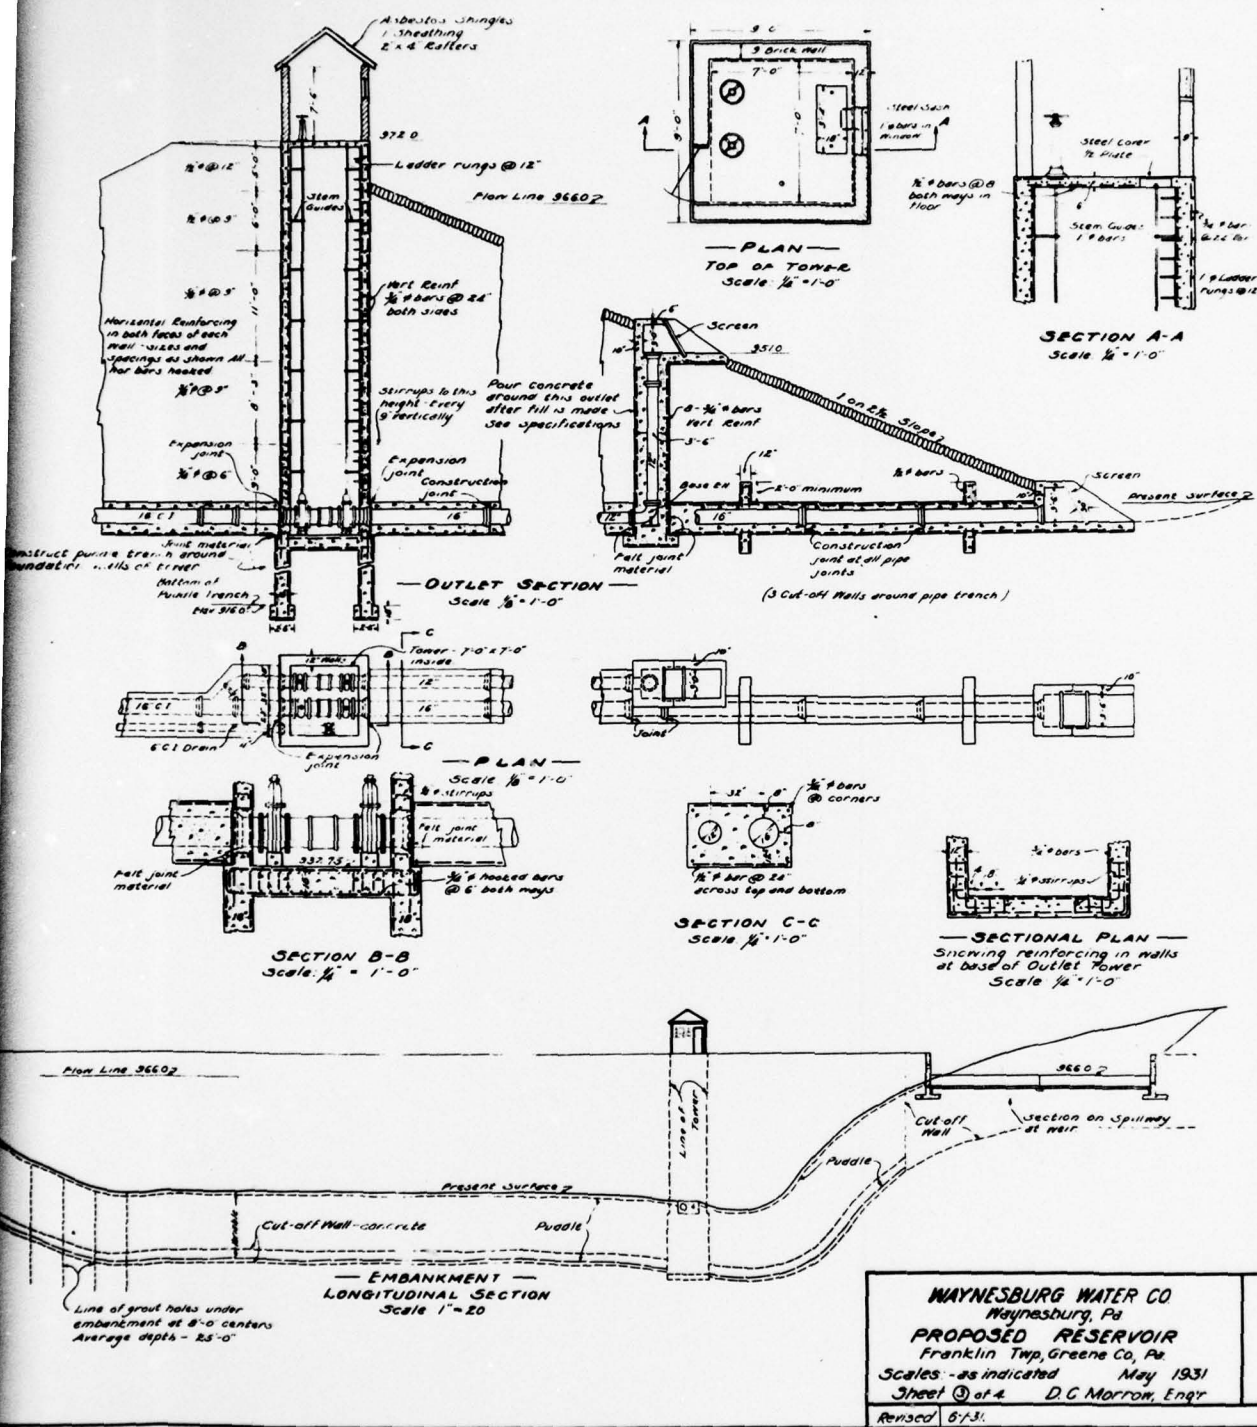
PLATE 2

- a. As designed, the dam is a homogeneous embankment with a clay cutoff trench on the center line of the embankment, extending for the full length of the dam. The average depth of the cutoff trench was 17 feet with a top width of 12 feet and a bottom width of 6 feet. A concrete core wall 12 inches thick and 2 feet high was constructed along the center line of the trench (Plates 2 and 3). The specifications required that the cutoff trench be backfilled with puddle clay in layers not to exceed 4 inches in thickness and tamped by using mechanical equipment. The only internal drainage system for the embankment consists of a rock drain along the downstream toe of the embankment.

The outlet works are located about 70 feet from the left abutment and consist of two submerged concrete intake structures at the upstream toe of the embankment, a 16-inch cast-iron pipe through the embankment, and a concrete control structure located at the upstream side of the dam crest at about mid-length of the pipe. The concrete control structure includes two gate valves which control flow through the outlet pipe. The gate valves are manually operated. The outlet pipe through the embankment is encased in concrete which includes two cutoff collars located near the upstream toe of the dam. Details of the outlet works are shown on Plate 2.

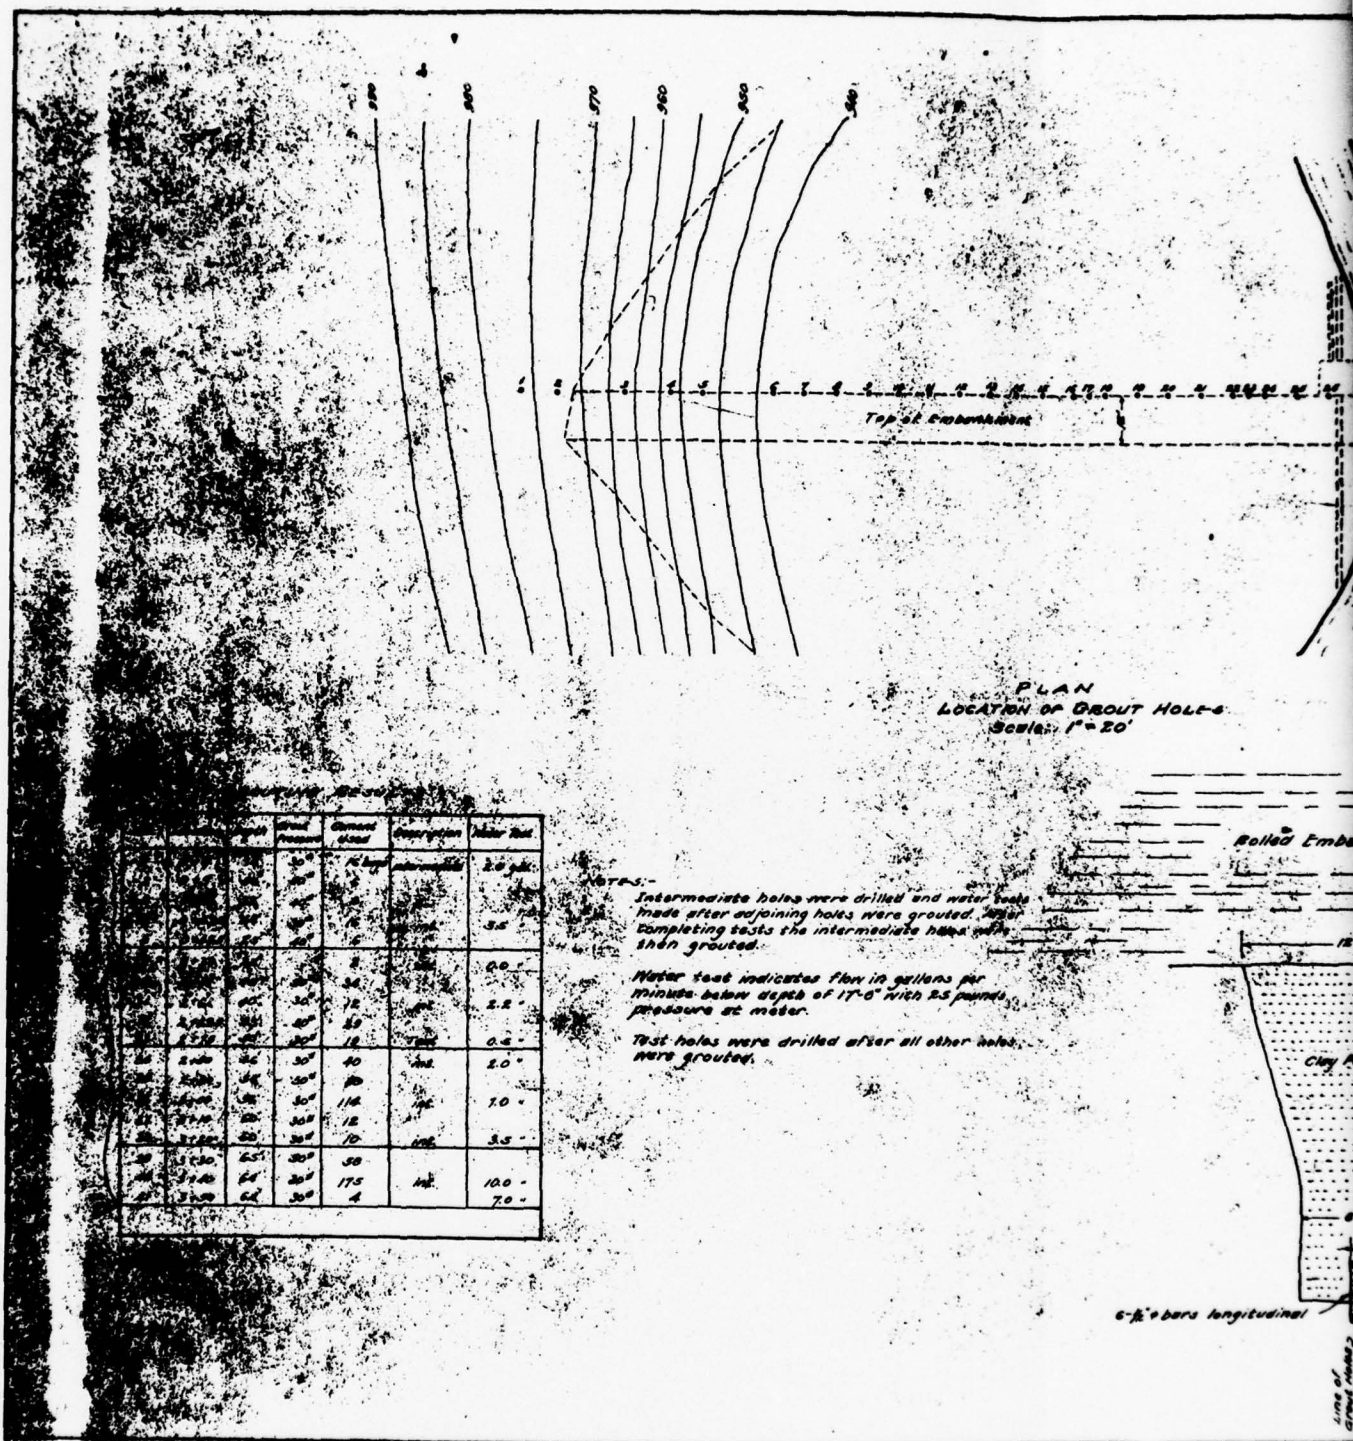
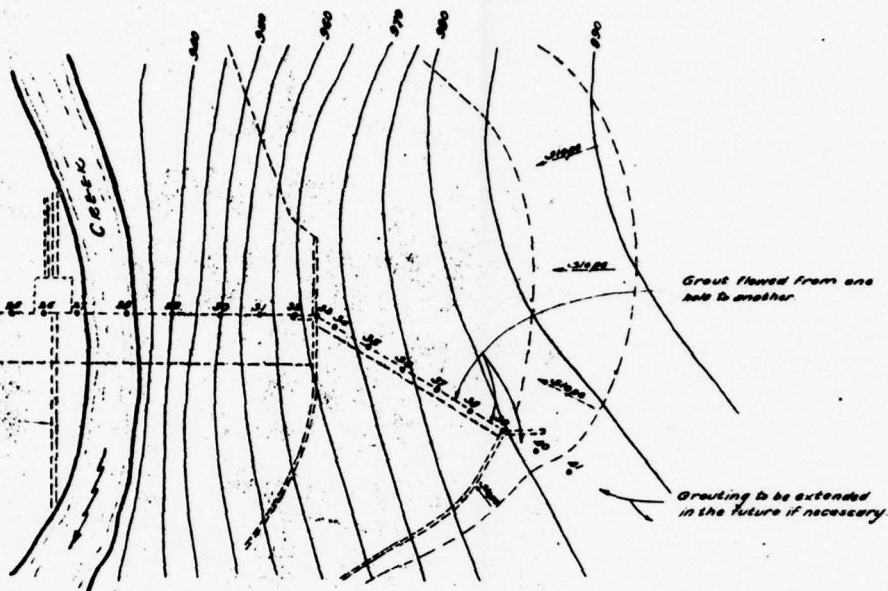
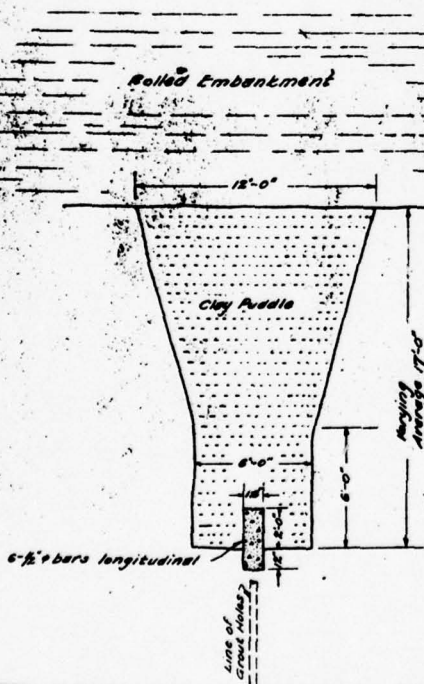
PLATE 3

- d. As indicated in Plate 3, the foundation of the dam was grouted through a single line of grout holes extending from the right abutment through the embankment and through the crest of the spillway. The grouting pressures ranged from 30 to 50 psi with cement takes ranging from 6 to 175 bags per hole. Subsequent to the initial grouting, additional holes were drilled for pressure testing. The pressure testing was conducted under a pressure of 25 psi starting from the bottom of the puddle clay cutoff wall. The water takes per hole ranged from zero to 10 gallons per minute (gpm). The high water take rates in the pressure tests corresponded to the locations of high grout take during the initial grouting.

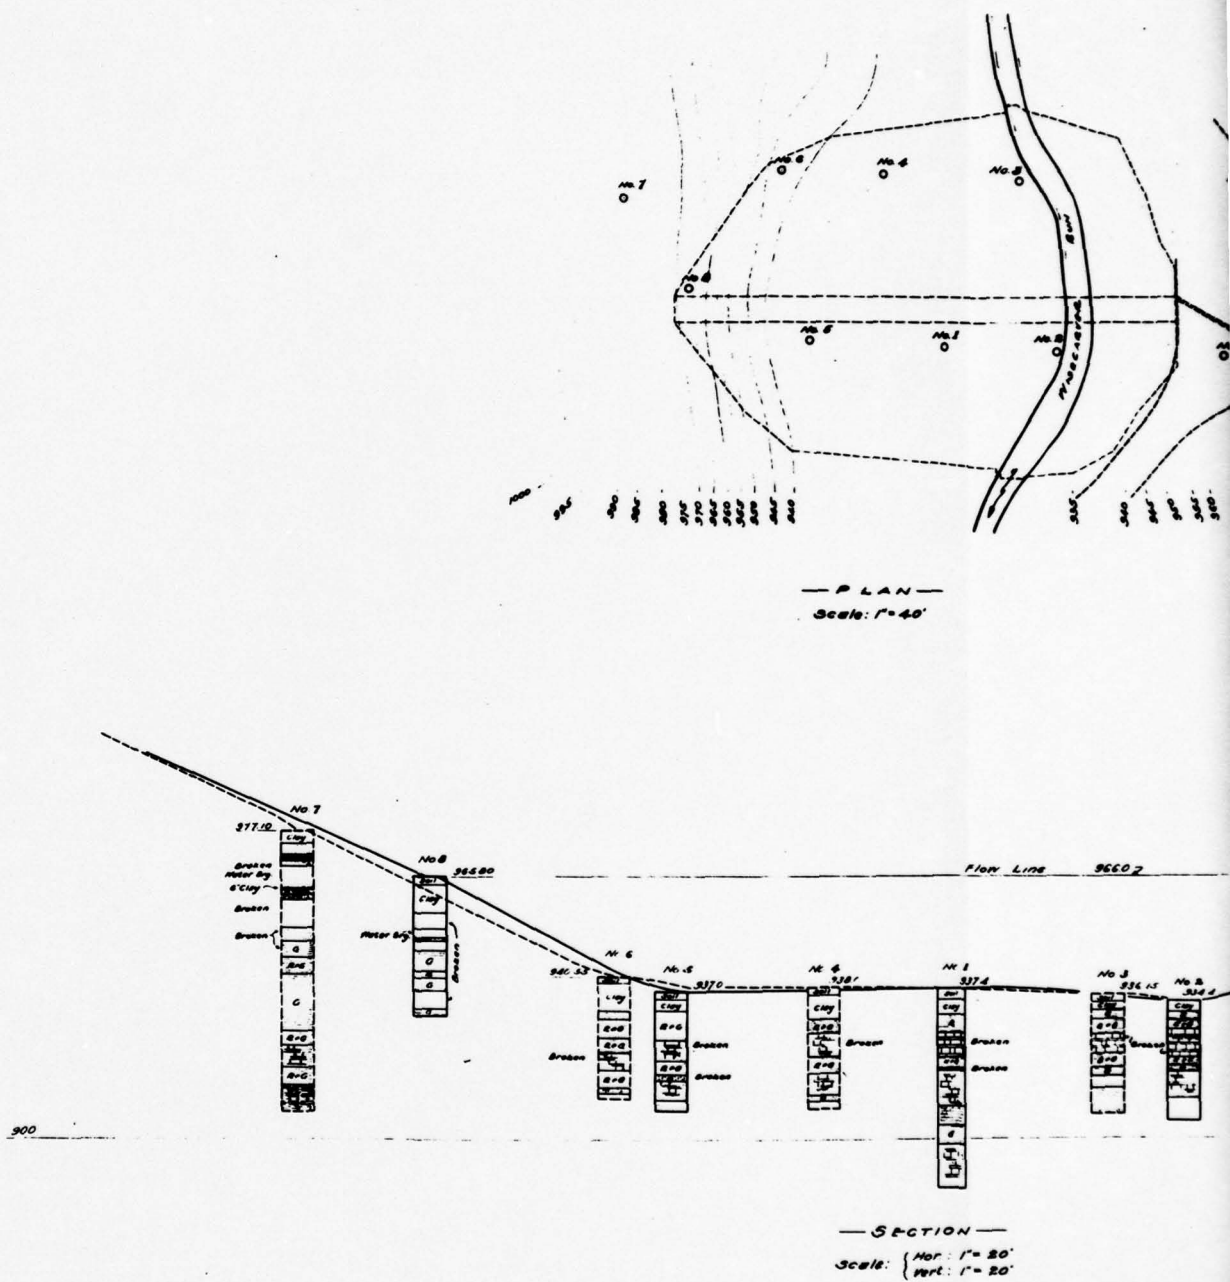
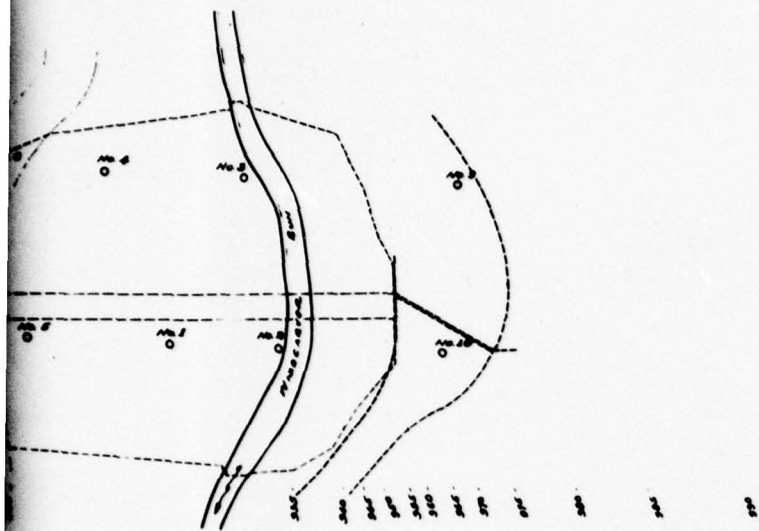
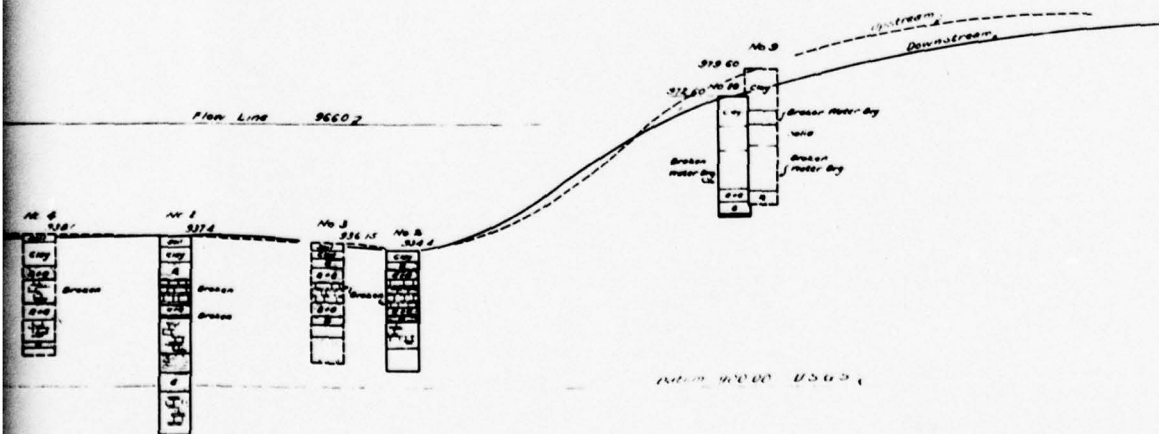
PLATE 4

- c. The boring locations for foundation exploration are shown in Plate 4. Boring logs, also shown in Plate 4, indicate that the subsurface profile along the axis of the dam consists of 2 to 5 feet of overburden underlain by alternating layers of shale and sandstone. The log of Boring 7, located on the right abutment, indicates that a coal seam was encountered at Elevation 970, which is approximately 4 feet above the normal pool level of the reservoir.
